Report No. 4124

THE CHESAPEAKE AND OHIO RAILWAY COMPANY

THOMPSONVILLE, MICH.

JUNE 10, 1967

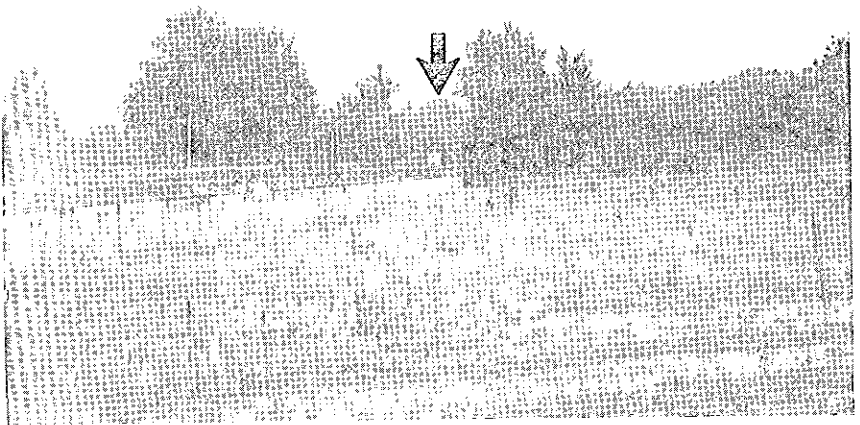
Photo No. 1

report However, as the vehicle approaches the track within 150 feet, the driver has an unobstructed view of the railroad throughout a distance of 500 to 600 feet south of the crossing (See Photo No. 1)

View southward from point on county road 100 feet west of the crossing. Train (arrow) is about 600 feet from the crossing.

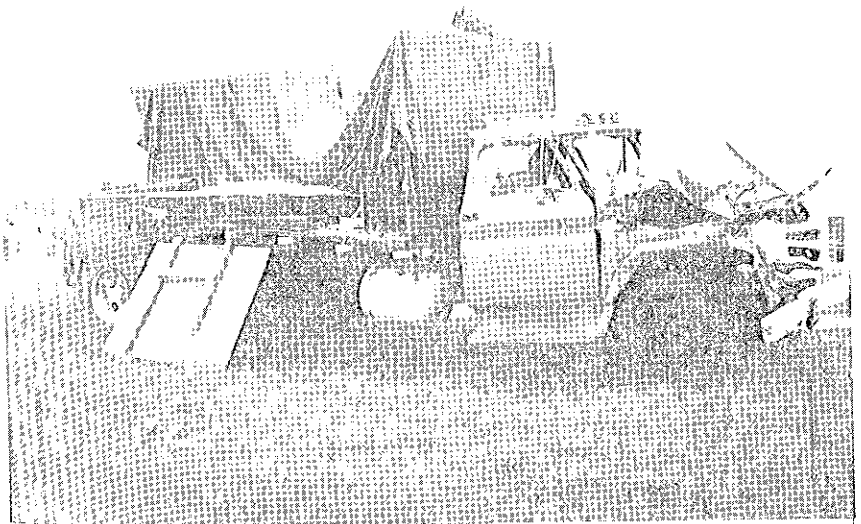
Photo No. 2

The motortruck (See Photo No. 2) had left Laredo, Texas, on June 6, 1967, and had proceeded to San Antonio, Texas, picking up migrant farm workers en route. It arrived at San Antonio about 2:00 a.m., June 8th, and departed approximately 3 hours 30 minutes later with the owner and his wife in the cab and with 30 migrant farm workers riding the canvas-covered truck body behind the cab. Its destination was a farm near Copemish, Mich., approximately four miles east of the crossing where the accident occurred. Since the transportation being performed involved migrant farm workers, exceeded 75 miles, and crossed State boundaries, the motortruck was subject to the Federal Highway Administration's Motor Carrier Safety Regulations.

Examination of the motortruck after the accident disclosed that the brakes for the wheels of the rear tandem axle were inoperative, due to not being connected to the brake system. This defective condition, however, apparently has no significant bearing on the accident.

The motortruck stopped upright in the northwest angle of the crossing, about 50 feet west and 70 feet north of the track and county road centerlines, respectively. It was heavily damaged.

Motortruck involved in accident

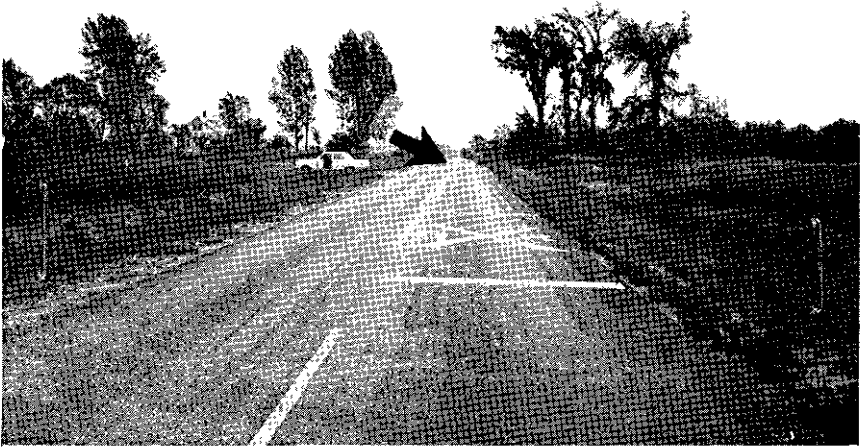
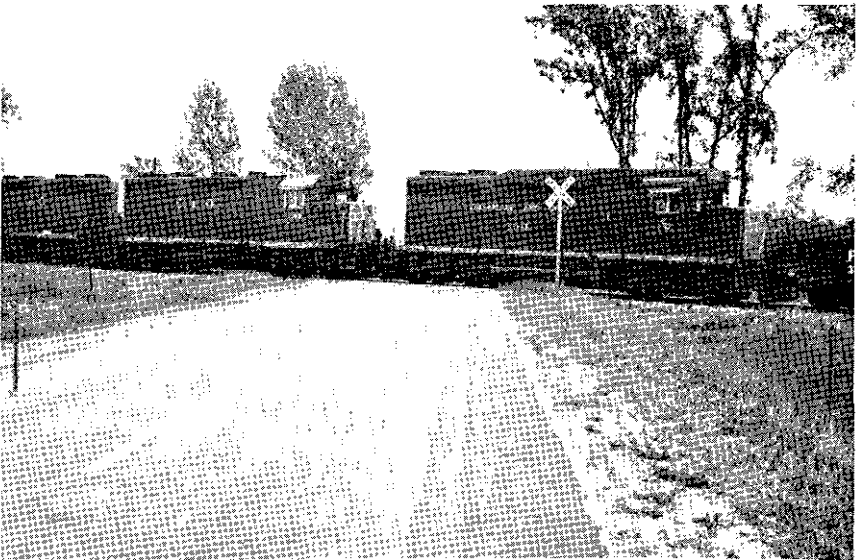
According to the owner-driver, the motortruck neared the railroad crossing at 35 to 40 miles per hour under heavy rain and poor visibility conditions. He stated that he did not see the railroad-crossing warning signs located west of the crossing (See Photos No. 3 and No. 4), and neither saw nor heard the train involved until he suddenly saw its locomotive crossing the county road immediately in front of his vehicle. The owner-driver further stated that he did not know he was in close proximity to the crossing before this time, and that he immediately turned his vehicle northward and applied its brakes. Apparently before its speed was materially reduced, the motortruck entered the crossing from the westward highway lane and struck the train. The

A circular railroad-crossing advance-warning sign, 36 inches in diameter, is adjacent to the south side of the county road, 402 feet west of the crossing. It is mounted on a mast 4 feet above the road surface and bears two intersecting diagonal stripes and the letters "RR". The letters and stripes are painted black on a yellow background.

A standard crossbuck railroad-crossing warning sign, bearing the words "RAILROAD CROSSING" in black letters on a reflectorized background, is mounted on a mast adjacent to the south side of the road, 17 feet west of the track centerline. The crossbuck is about 9 feet above ground level.

Truck driver's view approaching the crossing.  
Train approached from the right.

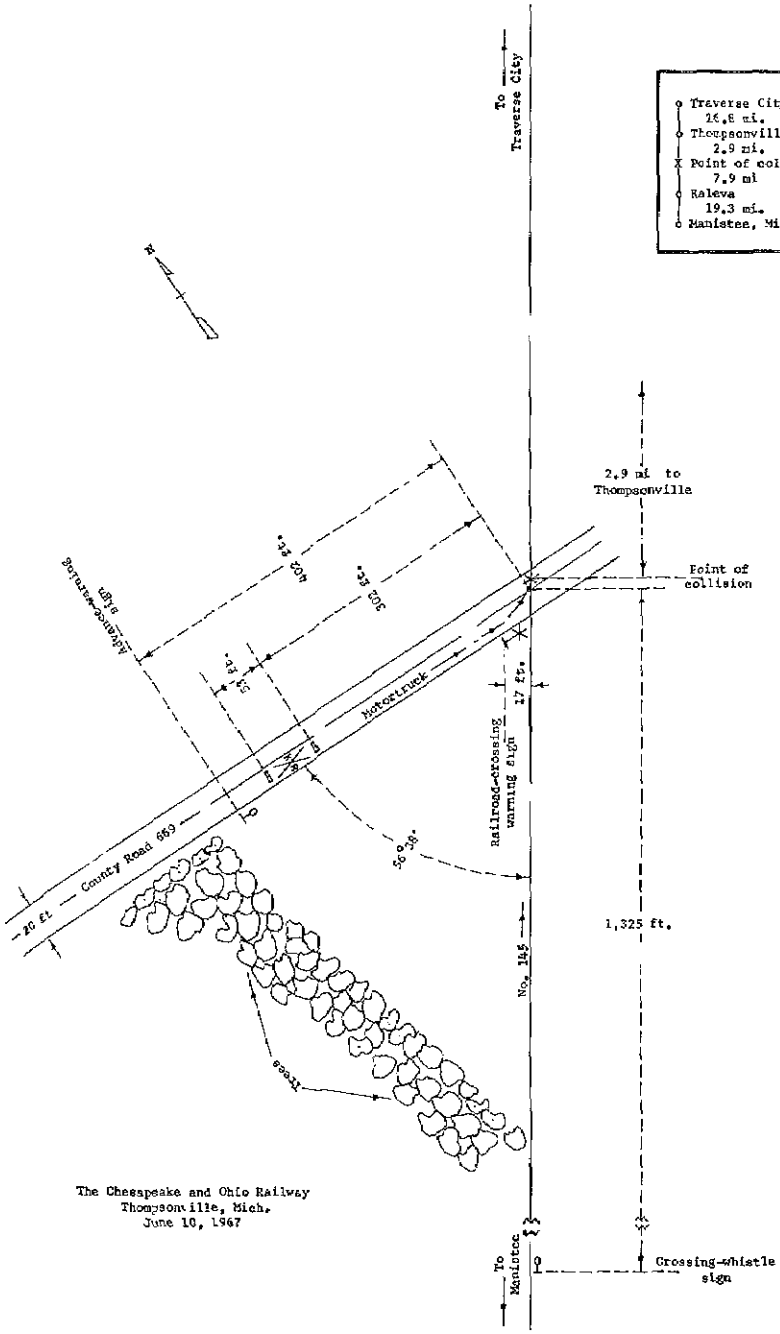
The Chesapeake and Ohio Railway  
Thompsonville, Mich.  
June 10, 1967

As an eastbound vehicle on the county road approaches the crossing, the driver's view of the railroad southward is obstructed by a wooded area in the southwest angle of the crossing, as indicated in the sketch appended to this

- Traverse City, Mich  
26.8 mi.
- Thompsonville  
2.9 mi.
- X Point of collision  
7.9 mi
- Haleva  
19.3 mi.
- Manistee, Mich.
