INTERSTATE COMMERCE COMMISSION

REPORT OF THE DIRECTOR OF THE BUREAU OF SAFETY IN RE
INVESTIGATION OF AN ACCIDENT WHICH OCCURRED ON
THE GRAND TRUNK RAILWAY SYSTEM AT BELSAY, MICH.,
ON MAY 28, 1930.

June 25, 1930.

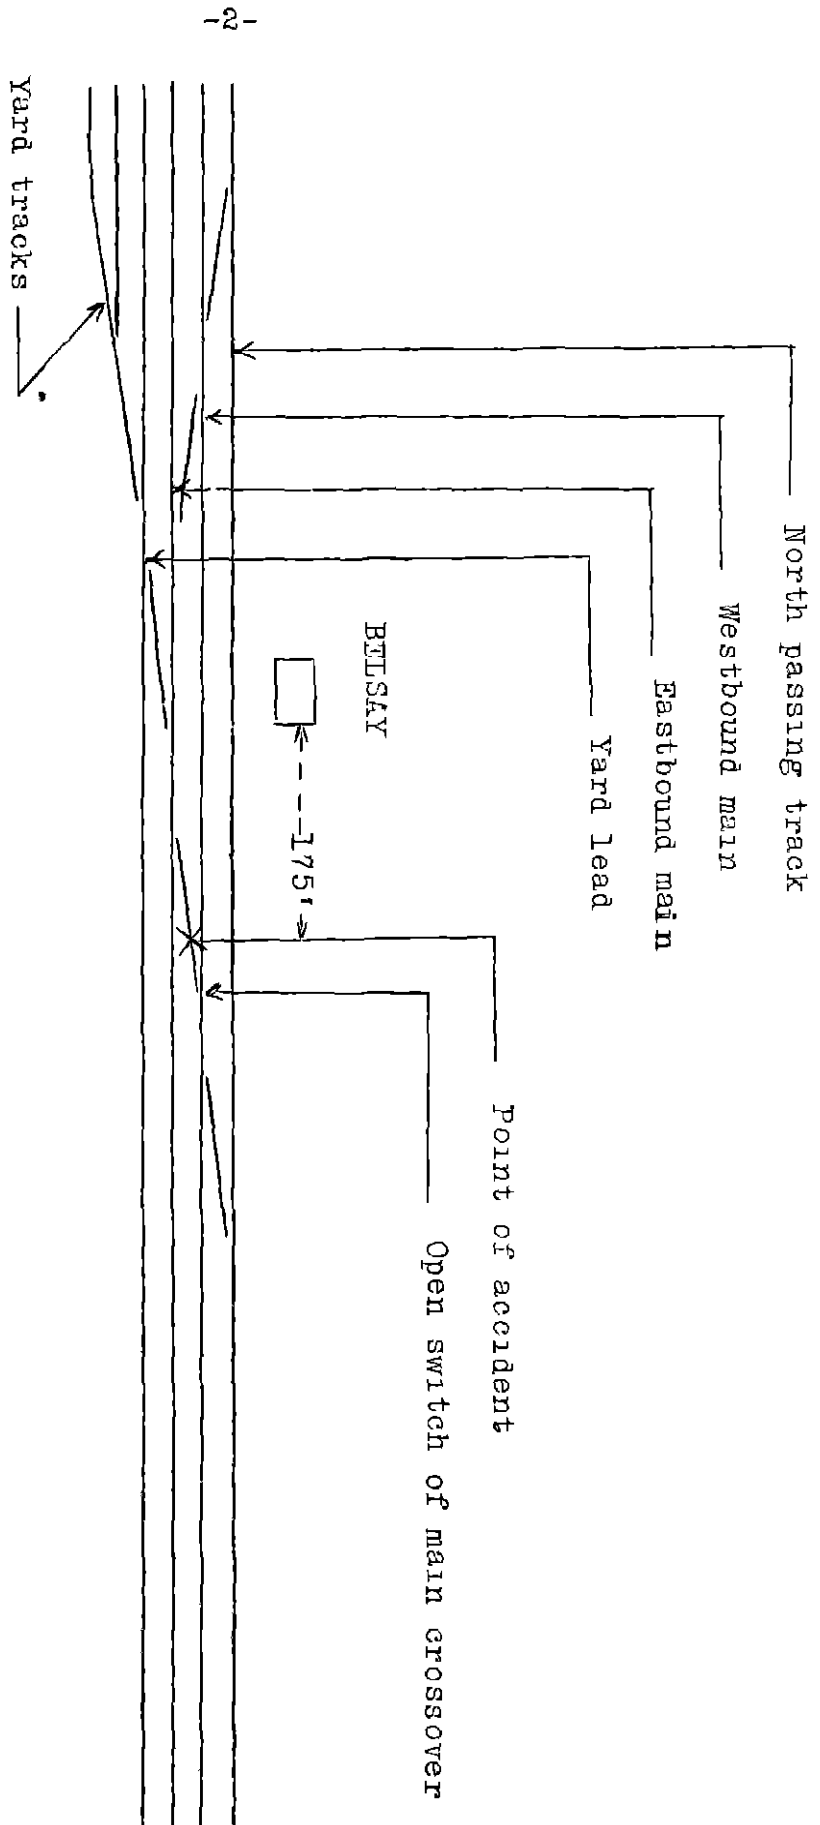
Inv. 1644
 GRAND TRUNK RAILWAY
 Belsay, Mich.
 May 28, 1930.

The east switch of the crossover involved in this accident is a facing-point switch for westbound trains and is of the ground-throw type. The switch-stand is located between the westbound main track and the north passing track. The switch has an oval, 6 x 10 inch, red banner, which shows only when set for diverging movements. The lamp has a 4 $\frac{1}{4}$ inch lens showing green for straight movements and red for diverging movements. Approaching from the east the

lamp and stand of this switch when set for a diverging movement are in line with the east switchstand of this crossover located 229 feet 8 inches to the east, and the view is also interfered with by the west switchstand of another crossover which has a 10 inch round banner, standing slightly higher and located 27 feet 8 inches east thereof. There were four other crossovers in this vicinity, connecting passing tracks with main tracks.

In approaching these switches from the east on the westbound main track, it was found that with all the other switches set in normal position and the east switch of the crossover between main tracks open, a portion of the red banner could be distinguished in cloudy weather for a distance of approximately 800 feet from the engineman's side of the engine cab, but a clear view of the banner could not be had until a point about 100 feet east of the switch had been reached. It could be definitely determined that the points were open at a distance of 380 feet.

It is recommended that the switchstands in the vicinity of the point of accident be so arranged that the lamp lenses and switch targets will be plainly visible from approaching trains.
