## INTERSTATE COMMERCE COMMISSION

### IN RE INVESTIGATION OF AN ACCIDENT WHICH OCCURRED ON THE NEW YORK CENTRAL AND MICHIGAN CENTRAL RAIL- ROADS AT PORTER, IND ON FEBRUARY 27 1921

MARCH 14 1921

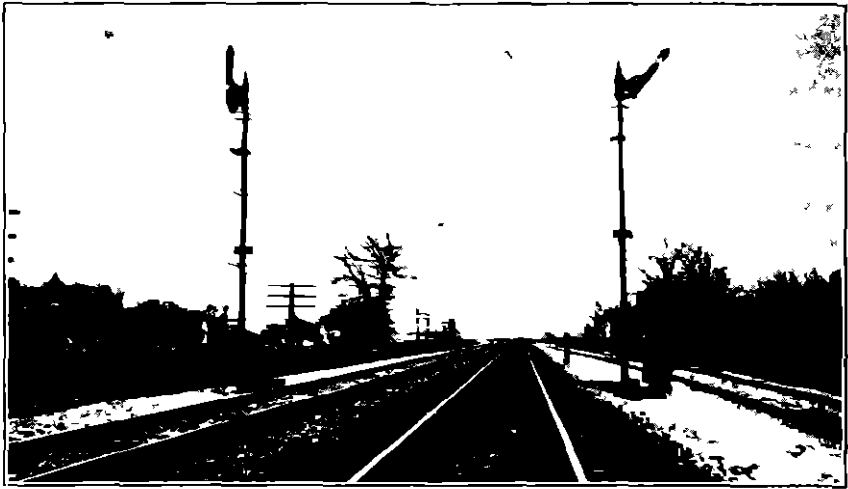
FIG. 1.—View looking east on Michigan Central tracks showing signal 2412

Engineman Long of train No. 20 stated that the last stop prior to the accident was at Gary at which point the brakes were operating properly. Approaching the distant signal the speed of his train was about 60 miles an hour as he came in sight of the distant signal it was displaying a caution indication before reaching it he made a service application of the brakes reducing the speed of his train about 10 miles an hour when the train had reached a point near the road crossing about the middle of the curve, Engineman Block called to him 'All the way' which indicated to him that the home signal was clear. He released the brakes and when the engine reached the tangent he looked for the home signal and thought he saw a green light above a red one. As he got close to the home signal he looked for the signal again but it was hidden by smoke and steam. At that time he thought the speed of his train was between 35 and 40 miles an hour he did not see the train-order signal on account of the smoke and steam neither did he see any hand signals. In discussing the indication of the home signal in response to the inquiry 'What do you think caused those indications that you received?' Engineman Long replied 'The only thing that could be if I did not have them is that I mistook the order board for the

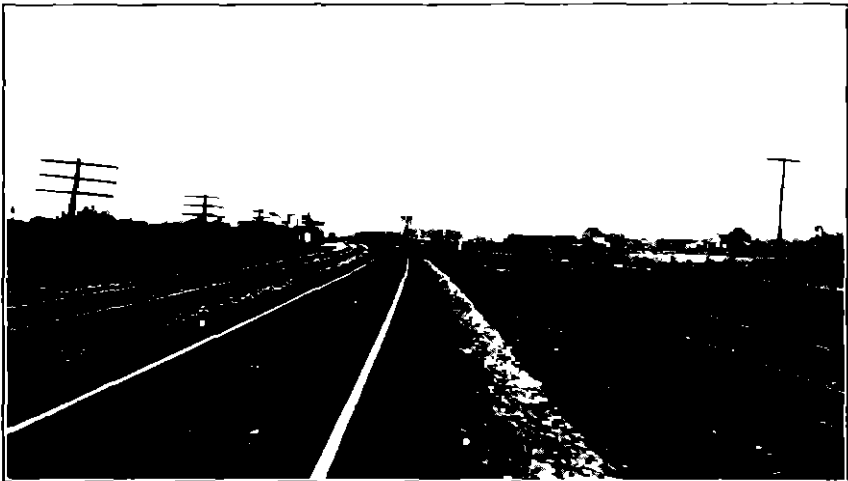
FIG. 2.—View of signal 35 had by Michigan Central engineman

The statements of eyewitnesses who observed the home signal at the time train No 20 was approaching together with the investigation of the signal system indicate that both blades of the home signal were in the stop position and displayed red indications when train No 20 approached and passed it

Observations made from an engine similar to that on train No 20 approaching the crossing on the Michigan Central from the west disclosed that from the fireman's side of the engine the home signal could be seen a distance of approximately 4 000 feet while by leaning out of the window on the engineman's side the home signal could be seen a distance of about 1 980 feet

The locations of the train-order and home signals were such that it would have been possible for the fireman to have mistaken the green indication of the train-order signal for a clear indication of the top blade of the home signal if the light on the latter was out or obscured by steam or smoke however with both blades of the home signal in the stop position as is shown by the evidence it would have been impossible for Fireman Block to see the indication he claims to have seen two green lights above a red light The possibility of a confusion of the signals from the engineman's side of the engine is much less than from the fireman's side on account of the signals being much closer when they first come within the engineman's range of vision

Investigation disclosed that the home signal was more or less obscured by steam or smoke and its location is such that similar conditions may frequently exist due to the relative location of a water plug near by, also that the position of the train-order signal was such that there was possibility of confusing it with other signals. If the home signal was in this instance obscured to such an extent that the approaching engineman was unable to see it, then it was his duty to reduce speed or to stop if necessary and determine its indication before passing it and it was necessary for him to receive clear indications from both the home signal and the train-order signal before passing them nevertheless every effort should be made to so locate signals that they are not likely to become obscured by steam or smoke from engines or to be confusing to employees required to observe their indications. It is believed the location of both the eastbound home signal and the train-order signal on the Michigan Central Railroad at this point should be improved.

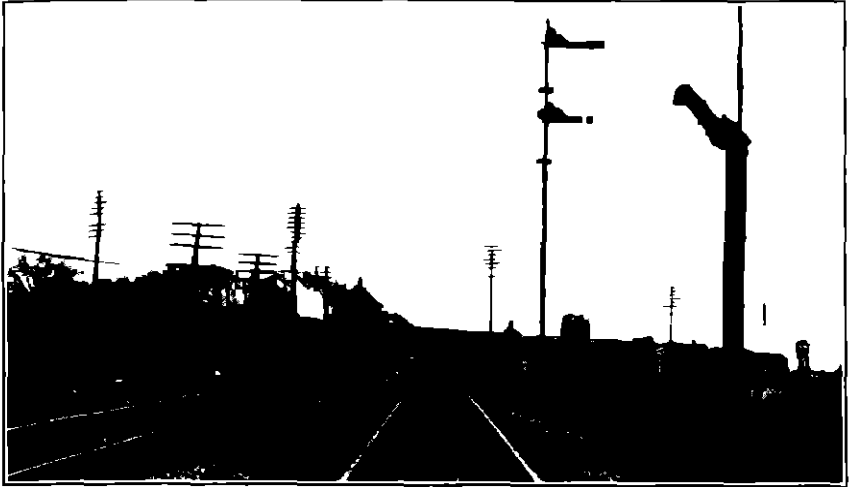
FIG. 3.—Signal 35, New York Central train on crossing.

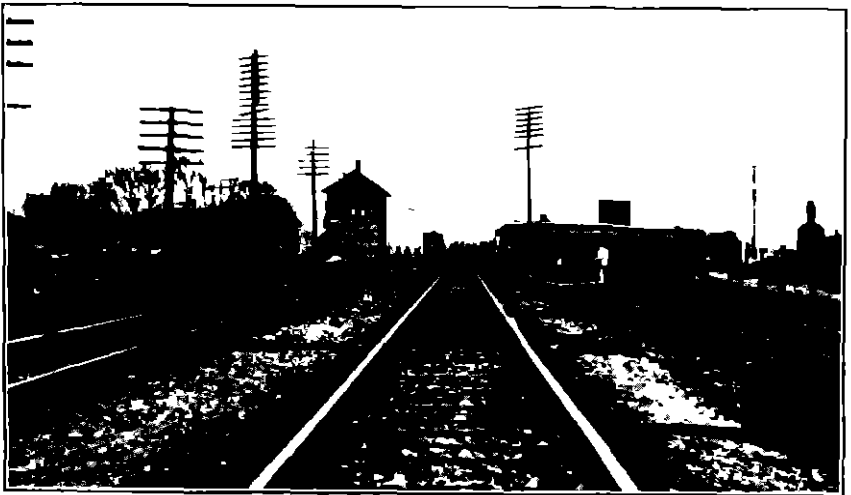
FIG. 4.—Drift east of signal 35.

The intended function of the derail used at this point was to derail a train and thereby prevent it from proceeding upon the crossing in case the engineman failed to obey the stop indication of the home signal. From the evidence in this case although the estimates as to the rate of speed of train No. 20 vary it is believed that with a train running at the maximum prescribed speed limit of 40 miles an hour the derail located 311 feet from the crossing does not afford the protection intended and that in order actually to provide the protection intended the maximum speed limit at this point should accordingly be reduced or the location of the derail changed.

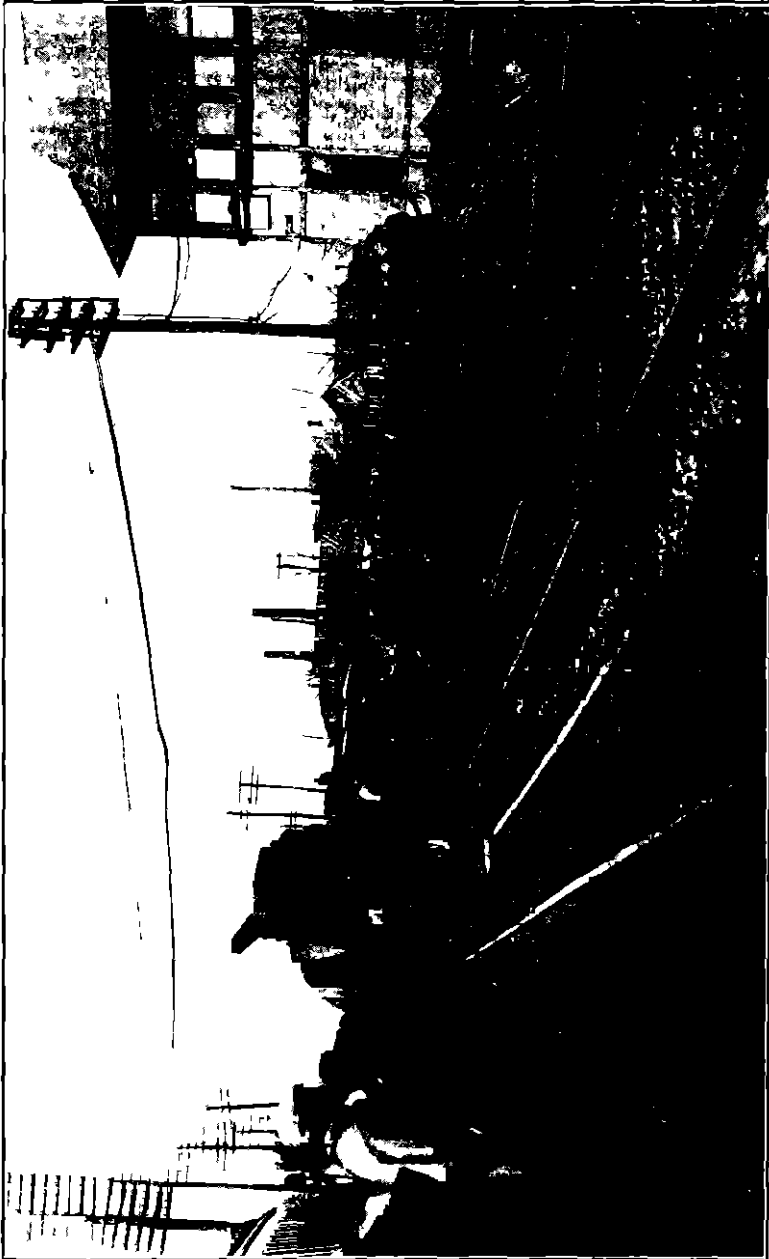
Fig 5 --View looking west on New York Central tracks toward crossing, interlocking tower on right
