REPORT OF THE DIRECTOR OF THE BUREAU OF SAFETY IN RE
INVESTIGATION OF AN ACCIDENT WHICH OCCURRED ON THE
PERE MARQUETTE RAILWAY AT EDMORE, MICH., ON
SEPTEMBER 25, 1931.

December 1, 1931.

Inv. No. 1723
 Pere Marquette Ry.,
 Edmore, Michigan,
 Sept. 25, 1931

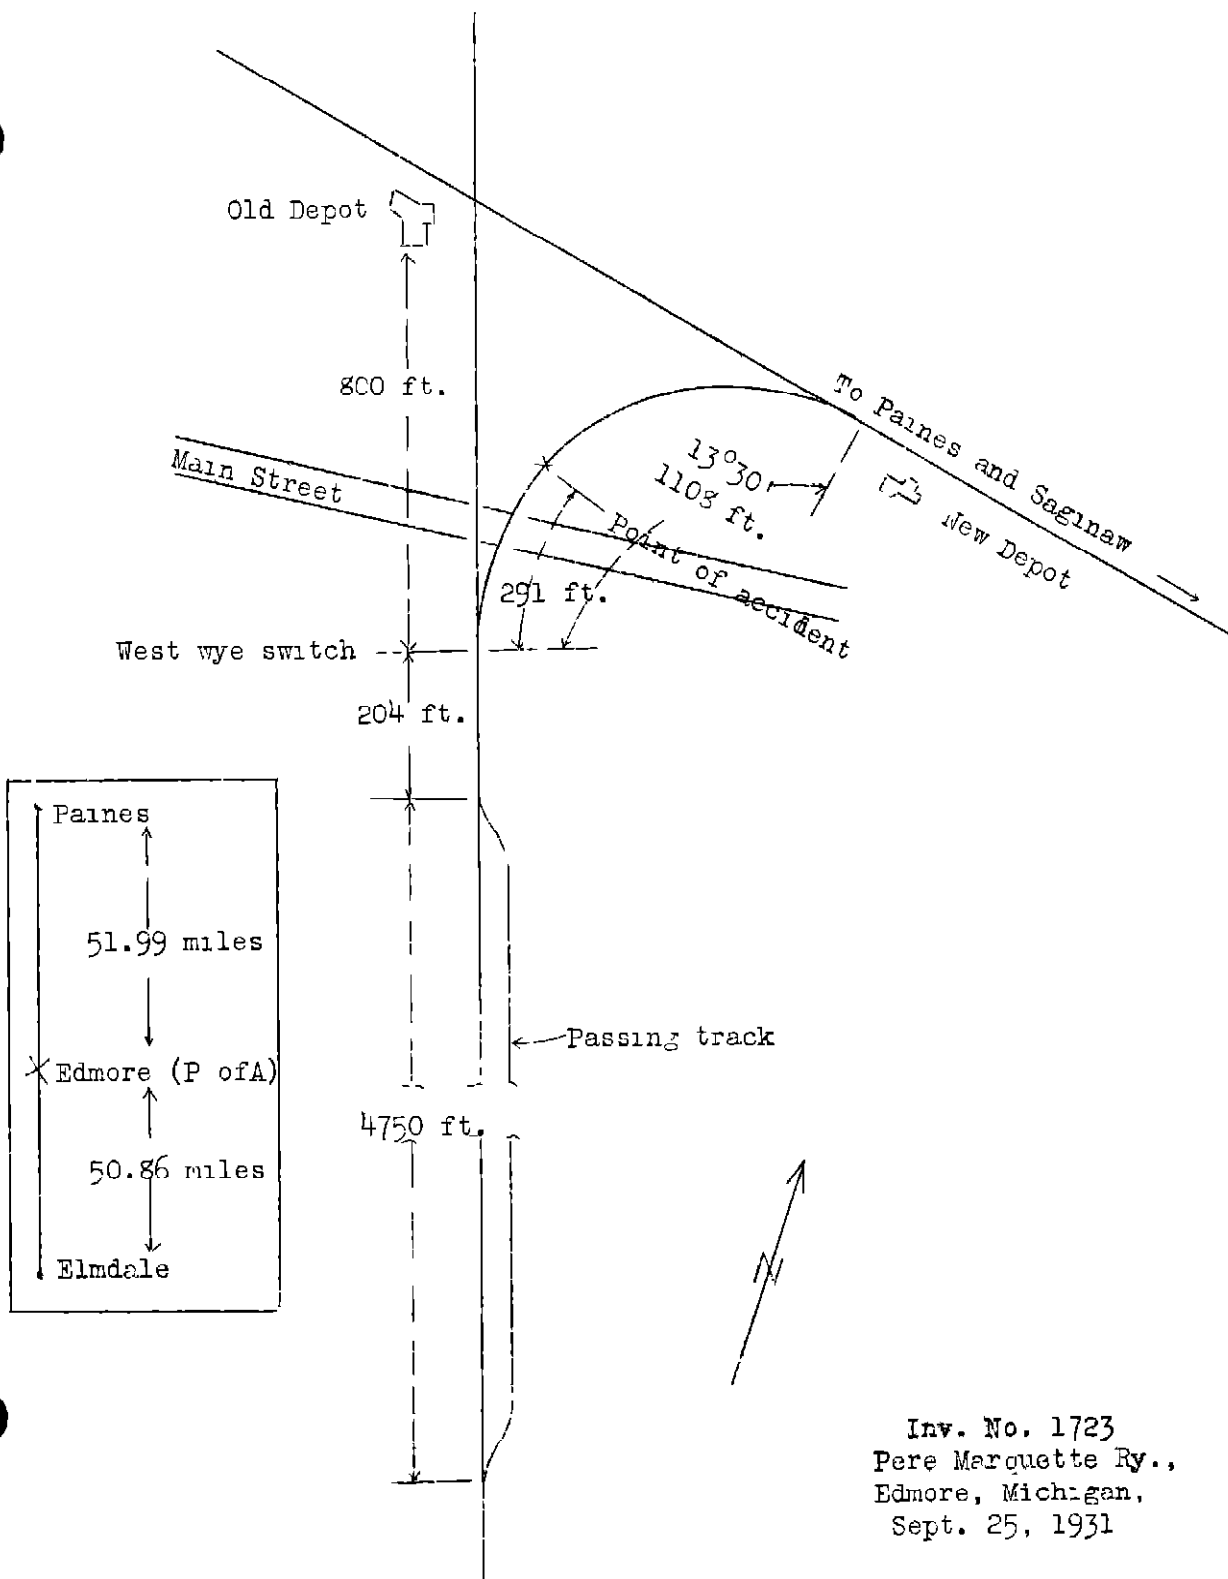
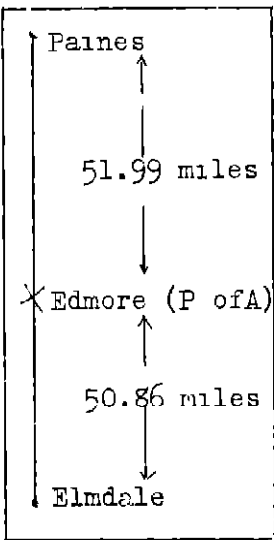
The accident occurred within yard limits, on the southeast leg of the wye, at a point 291 feet east of the west wye switch; approaching this point from the west, the track is tangent for a distance of 3,229 feet, followed by the wye track, which is on a $13^{\circ} 30'$ curve to the right, 1,108 feet in length. Within these limits the grade is descending, varying from 0.24 to 0.71 per cent, being 0.42 per cent at the point of derailment. This leg of the wye has a No. 10 turn-out and is laid with 90-pound rails, averaging 38 feet 6 inches in length, double-spiked, fully tie-plated, with tie-rods spaced about 5 feet apart, and is ballasted with washed gravel to a depth of about 10 inches; it is well maintained. The wye is used as a portion of the main line, and special instructions in the time-table provide that the normal position of the switches is for movements over the wye and restrict the speed of all trains to 8 miles per hour while making this movement.

Engine 708, with tender coupled, came to rest on its left side parallel with the track, with the rear of the tender 363 feet east of the west wye switch, the combination mail and baggage car, the first two box cars, and about half of the third box car passed on by the derailed engine and came to rest in an upright position with the head end of the first car 165 feet east of the front end of the engine. The front truck of the mail car was demolished and the left side of the car was torn off almost entirely by contact with the derailed engine; the box car behind the mail car was slightly damaged and had the front pair of wheels of its rear truck derailed, but none of the remaining equipment was derailed or damaged. The employees killed were the engineman and the fireman and the employee injured was the brakeman-baggage man.
