REPORT OF THE DIRECTOR
BUREAU OF SAFETY

ACCIDENT ON THE
GRAND TRUNK WESTERN RAILROAD

KALAMAZOO, MICH.

December 2, 1939

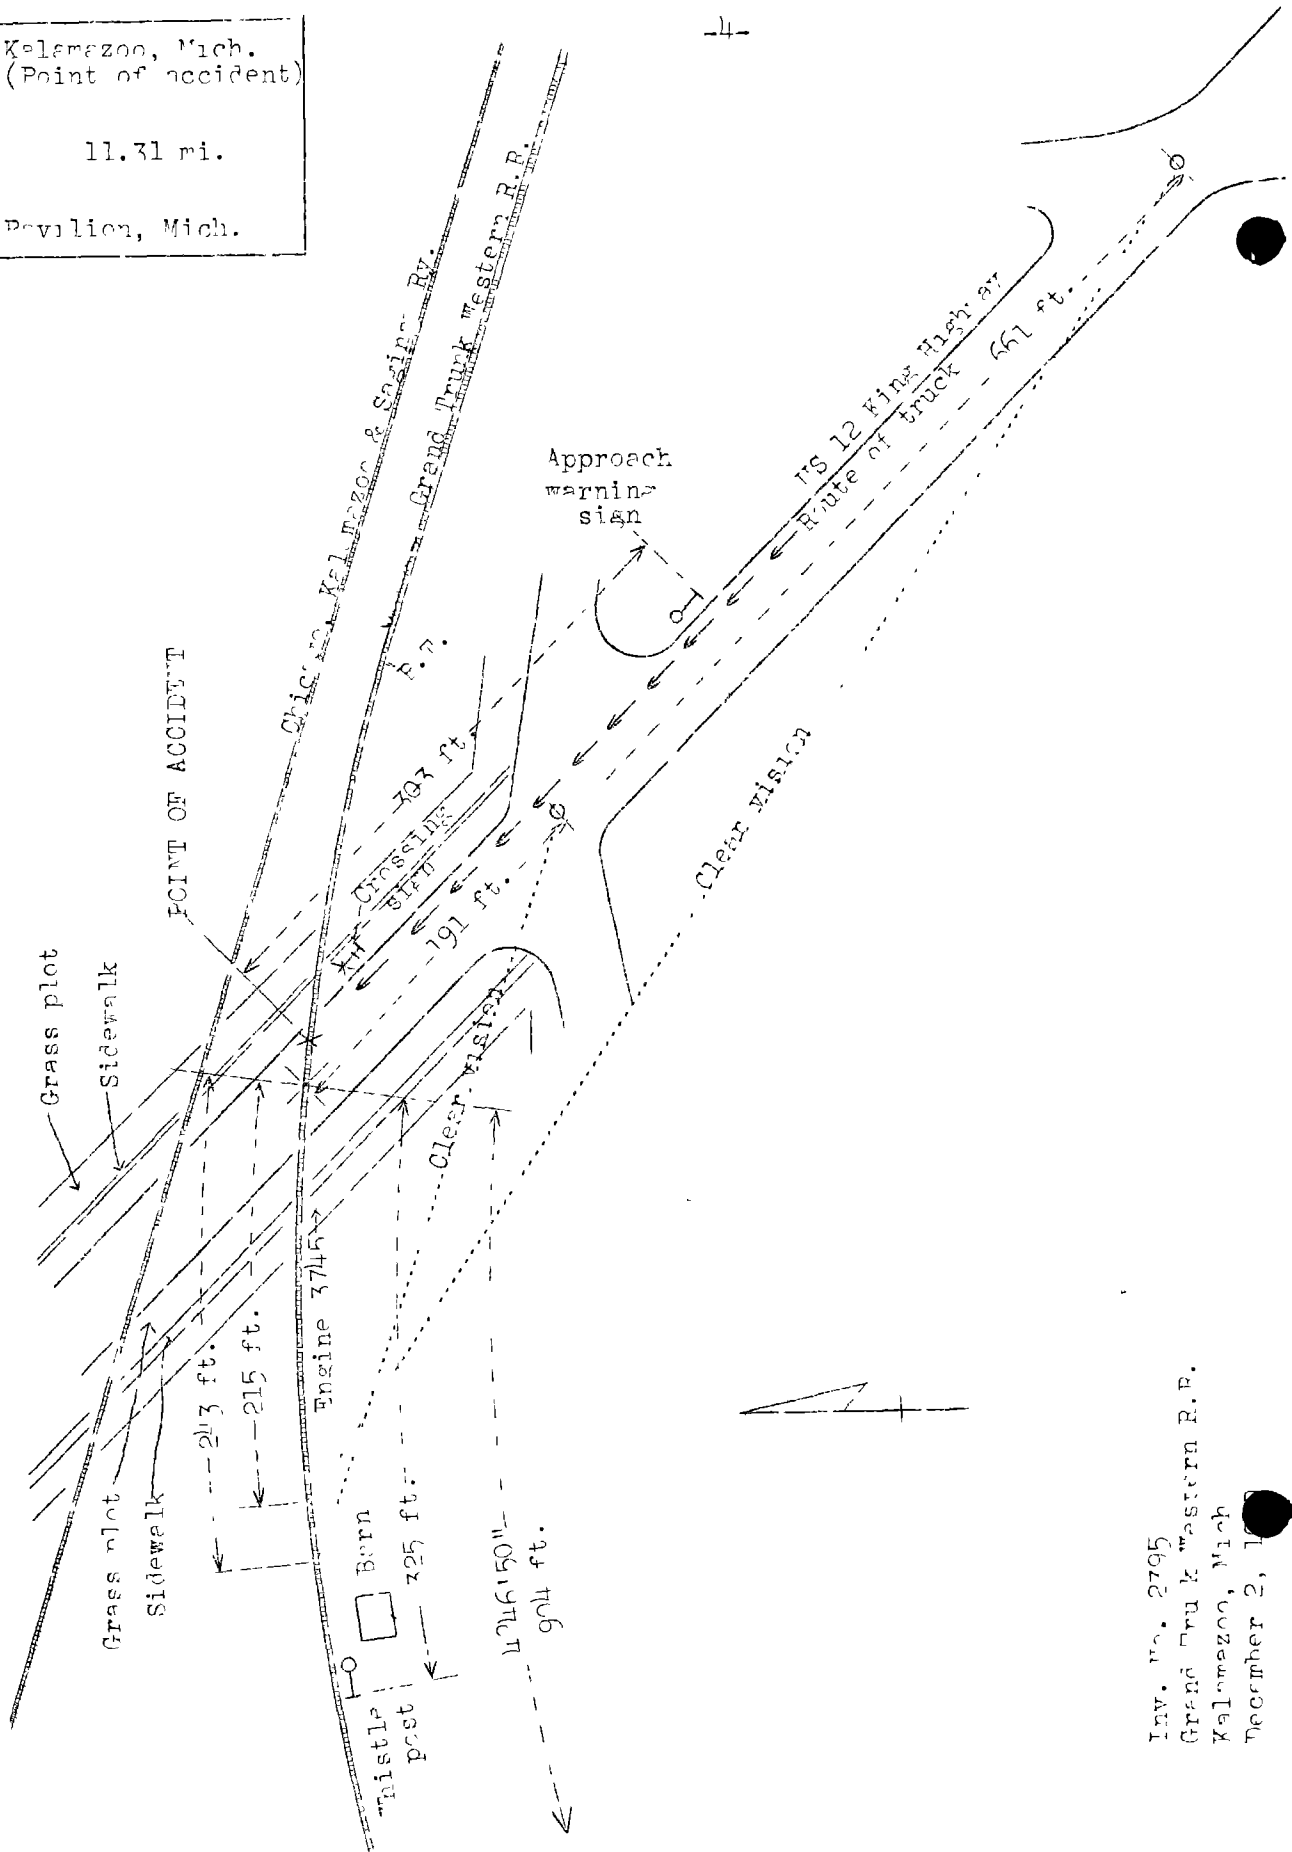
Inv. No. 2795
 Grand Trunk Western R.P.
 Kalamazoo, Mich
 December 2, 19

* Kalamazoo, Mich.
 (Point of accident)

11.31 mi.

o Pavilion, Mich.

This accident occurred on that part of the Chicago Division designated as the Kalamazoo Subdivision which extends between Pavilion and Kalamazoo, Mich., a distance of 11.31 miles. This is a single-track line over which trains are operated by timetable and train orders; there is no block system in use. At the intersection involved the railroad extends practically east and west; the highway extends northwest and southeast. The accident occurred within the city limits of Kalamazoo, at a point where route U.S. 12, locally known as King Highway, crosses the track at an angle of 38 degrees.
